HISTORIC AMERICAN BUILDINGS SURVEY
INVENTORY

2. NAME *Orrin Thompson Mansion*

DATE OR PERIOD *1832*
STYLE *Greek Revival*
ARCHITECT
BUILDER *Orrin Thompson*

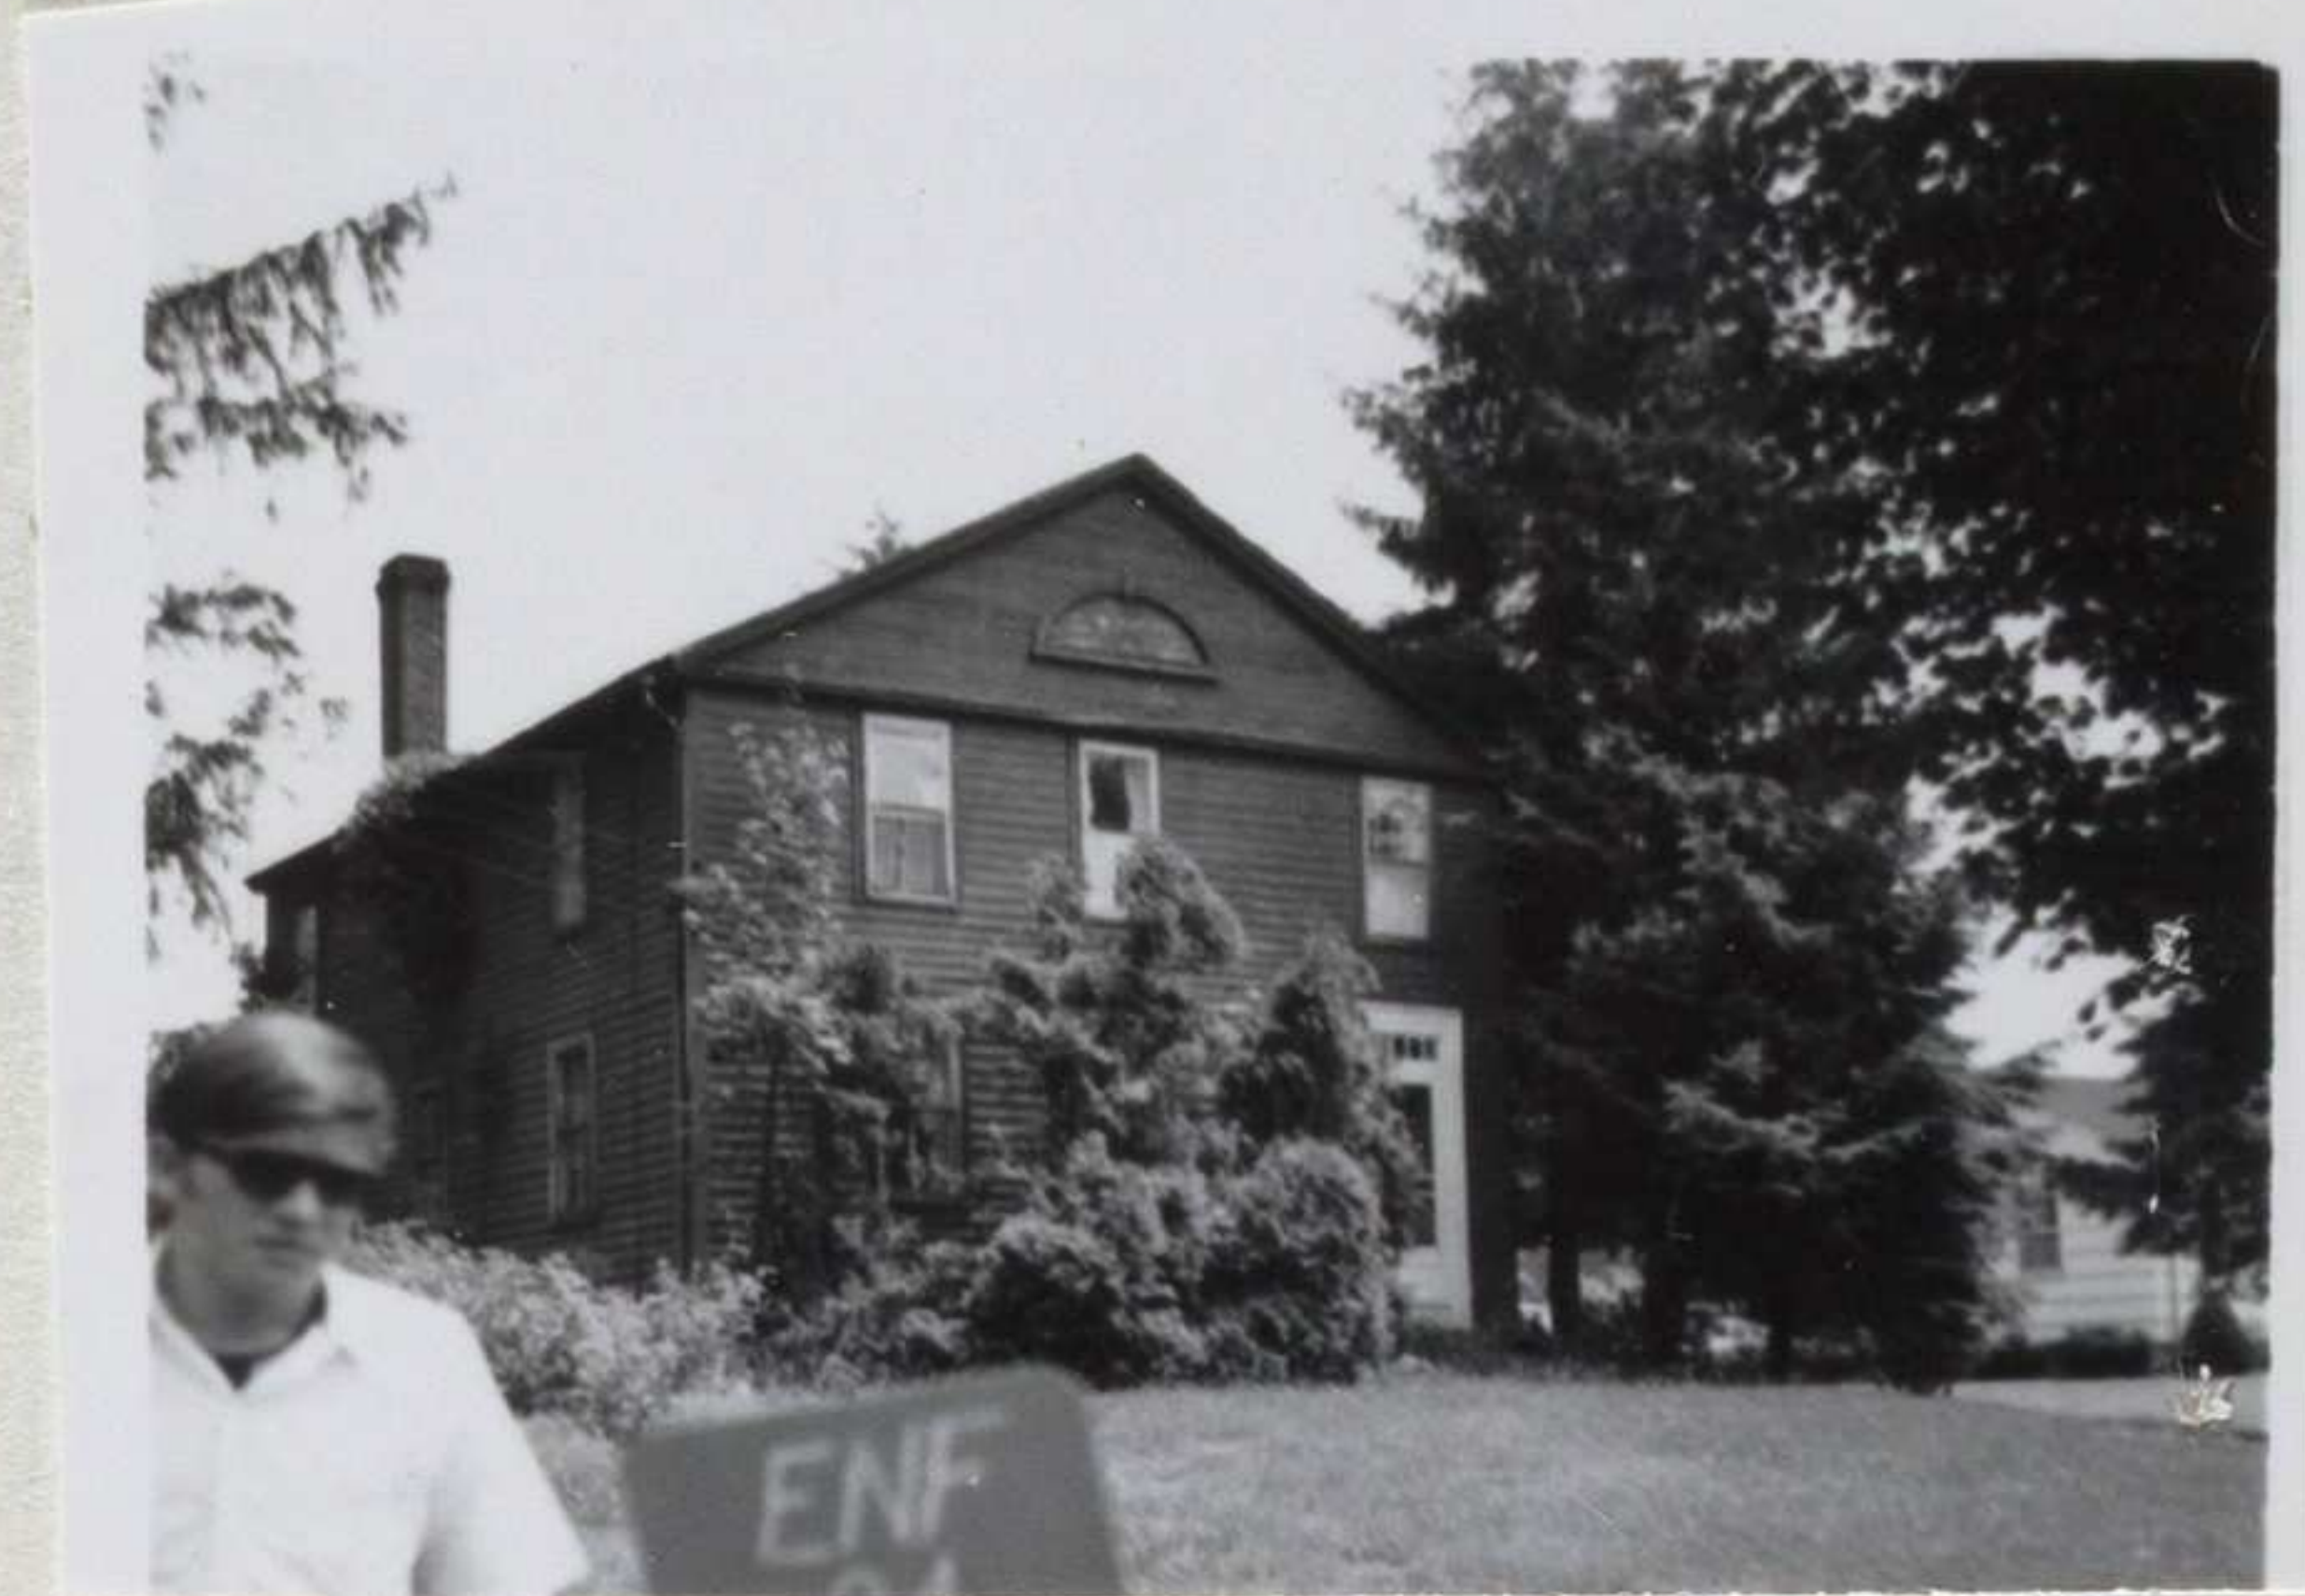
</p>		<p>7. PHOTOGRAPH <i>Enf 24</i>

<p>1. STATE <i>CT</i> COUNTY <i>Hartford</i> TOWN <i>Enfield</i> VICINITY STREET NO. <i>400 ft SE of corner of King Street and Mullen Rd.</i> ORIGINAL OWNER ? ORIGINAL USE <i>Residence</i> PRESENT OWNER ? PRESENT USE <i>Residence</i> WALL CONSTRUCTION <i>clapboard</i> NO. OF STORIES <i>2</i></p>		<p>HISTORIC AMERICAN BUILDINGS SURVEY INVENTORY</p>	
		<p>2. NAME DATE OR PERIOD <i>1820's or 30's</i> STYLE <i>Greek Revival</i> ARCHITECT BUILDER</p>	
		<p>3. FOR LIBRARY OF CONGRESS USE</p>	
<p>4. NOTABLE FEATURES, HISTORICAL SIGNIFICANCE AND DESCRIPTION OPEN TO PUBLIC <i>No</i> <i>Like most houses of its period this ex-ample has its pediment formed by a shallow pitched roof facing the street. This pediment is centered with a semi circular window of the usual dimensions. Unfortunately the windows and door are not original. The foundation is of brick and the clapboards are darkly stained.</i></p>

<p>5. PHYSICAL CONDITION OF STRUCTURE Endangered ? Interior ? Exterior <i>Fair</i></p>			
<p>6. LOCATION MAP (Plan Optional)

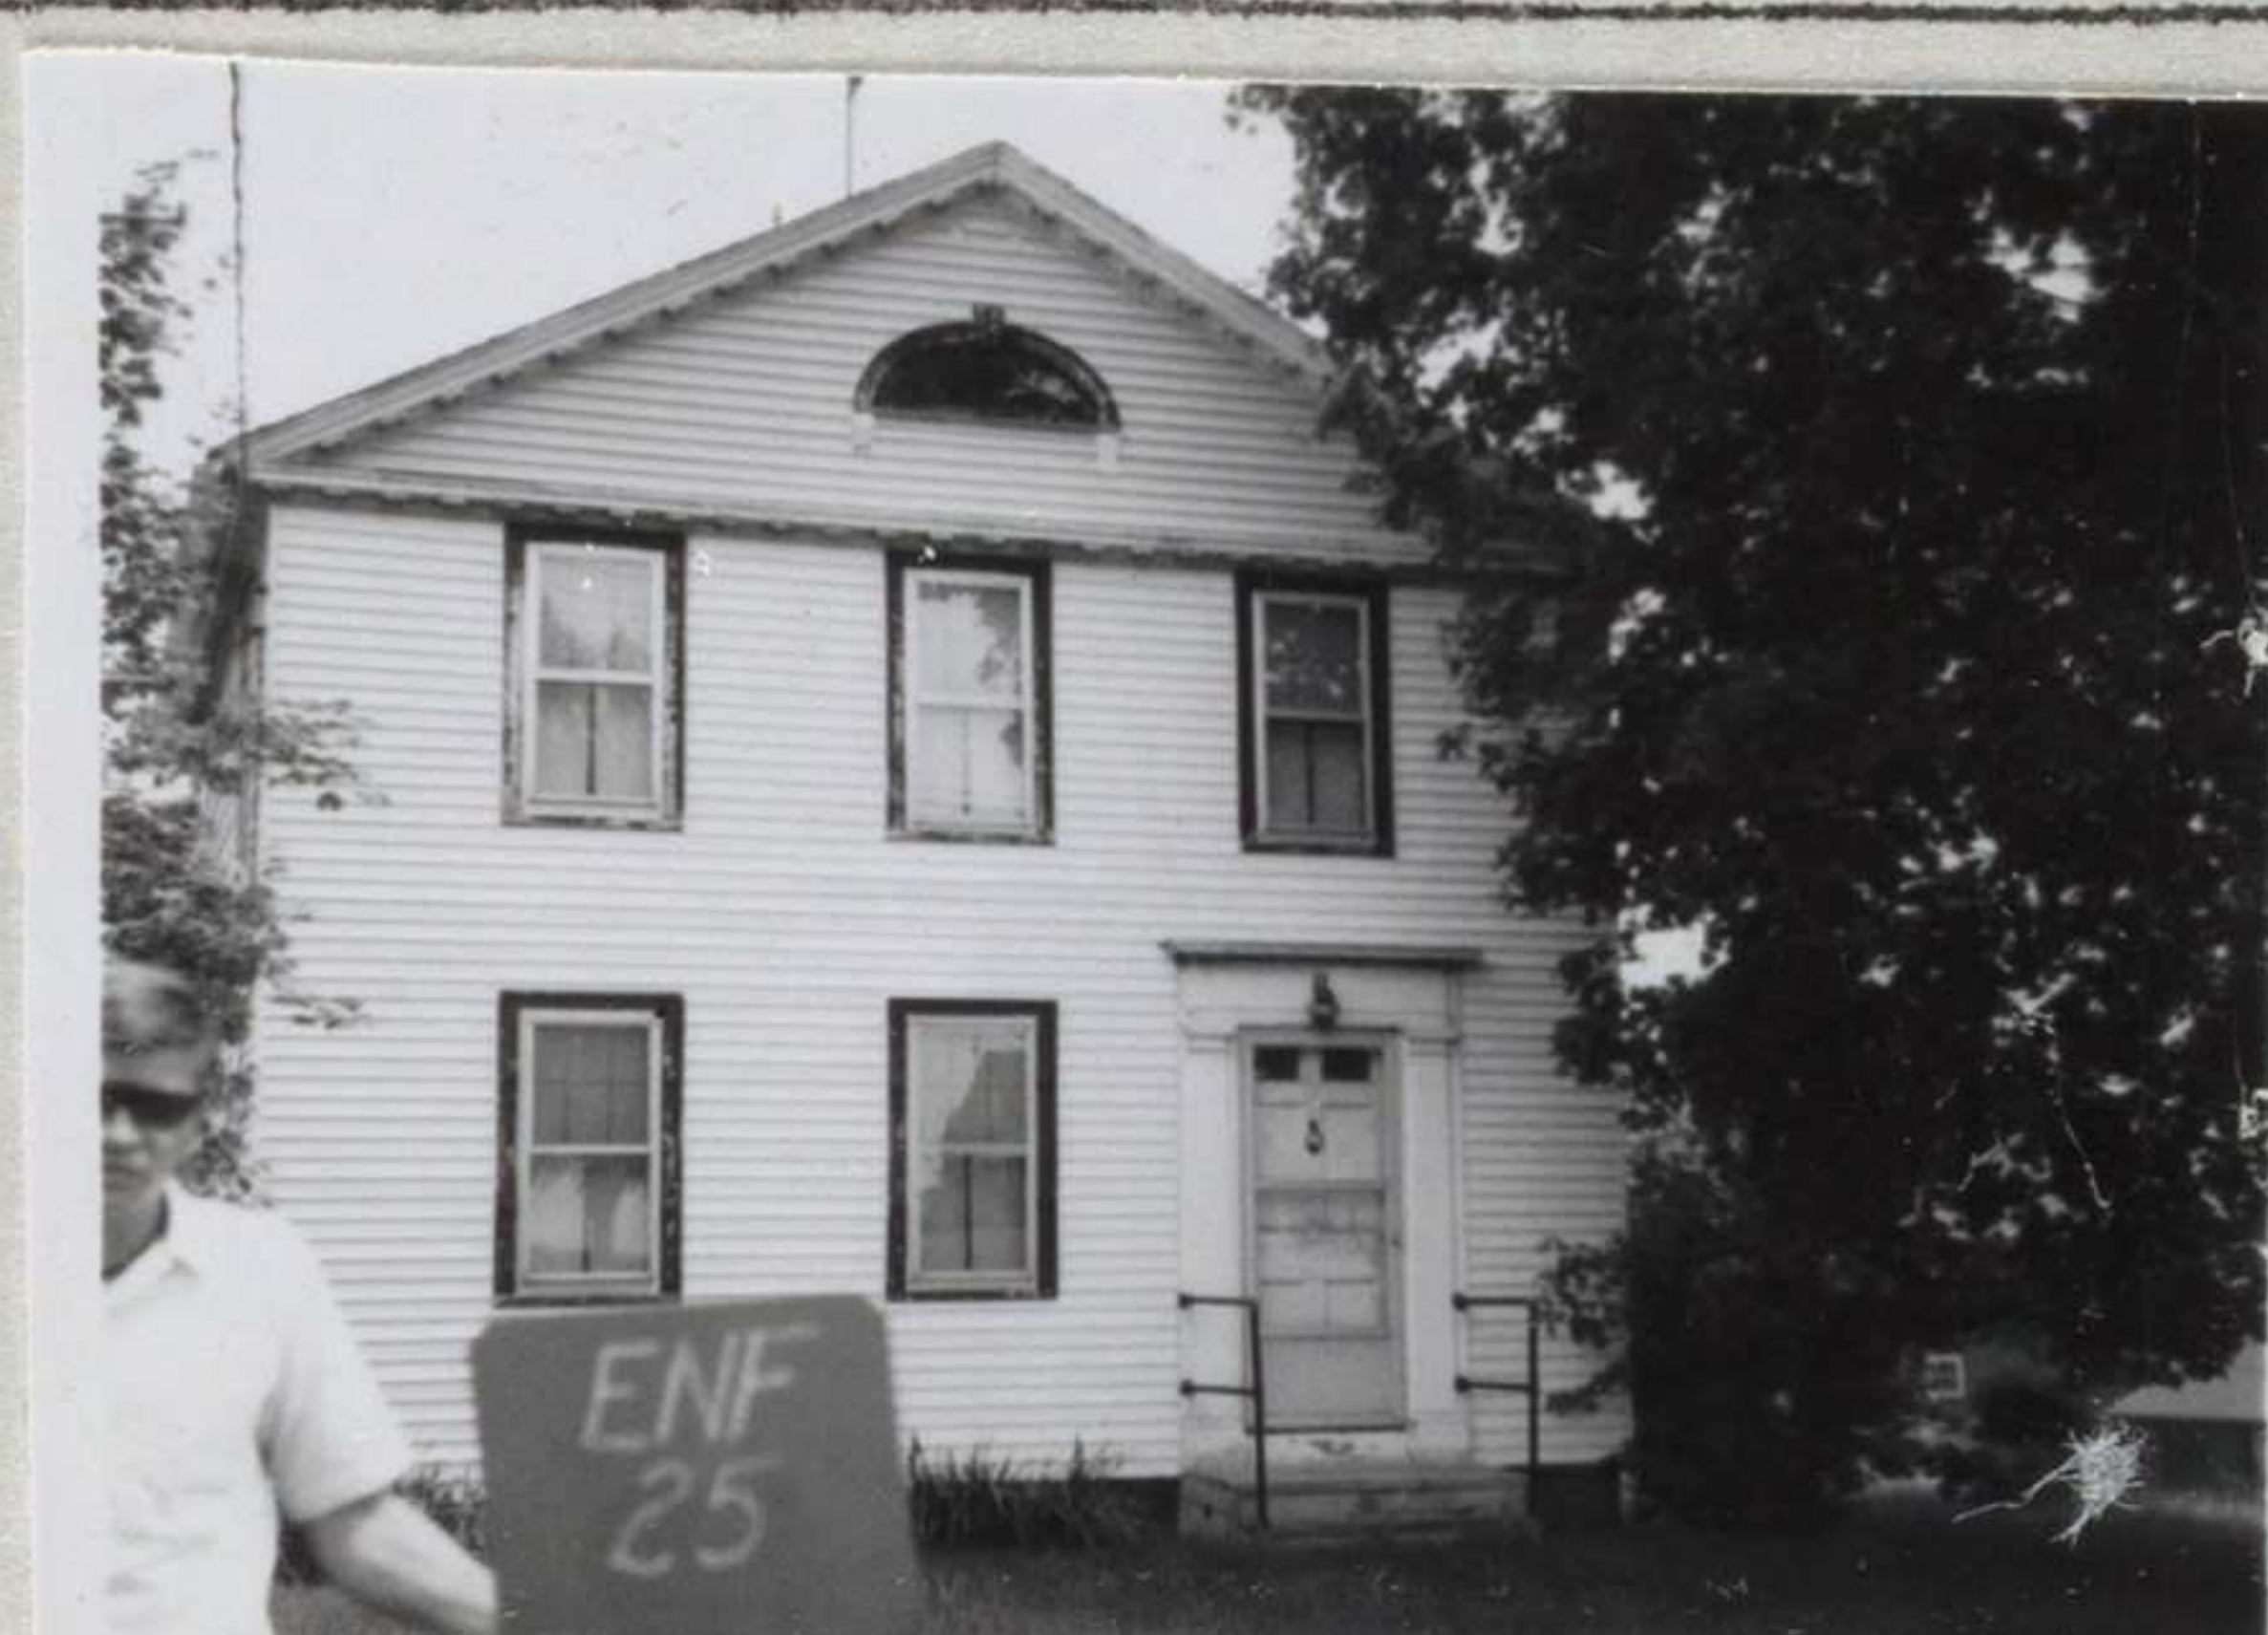
<p>7. PHOTOGRAPH <i>Enf 25</i></p>

<p>1. STATE <i>CT</i> COUNTY <i>Hartford</i> TOWN <i>Enfield</i> VICINITY STREET NO. <i>E side of King St, 100 ft S of Kings Court.</i> ORIGINAL OWNER ? ORIGINAL USE <i>Residence</i> PRESENT OWNER ? PRESENT USE <i>Residence</i> WALL CONSTRUCTION <i>clapboard</i> NO. OF STORIES <i>2</i></p>		<p>HISTORIC AMERICAN BUILDINGS SURVEY INVENTORY</p>	
		<p>2. NAME DATE OR PERIOD <i>1820's ?</i> STYLE <i>Greek Revival</i> ARCHITECT BUILDER</p>	
		<p>3. FOR LIBRARY OF CONGRESS USE</p>	
<p>4. NOTABLE FEATURES, HISTORICAL SIGNIFICANCE AND DESCRIPTION</p> <p>OPEN TO PUBLIC</p> <p><i>Most of this house's features are the characteristic forms of its period. The road facing pediment is centered by a semi-circular window and formed by a shallow pitched roof. The foundation is of brownstone and facade is made up of 3 bays, the door being to the right. Although the features are familiar however, the house is one of the finest examples of its type in the area due to the delicacy of its dentil carving. The banded hole designs not only decorate the accentuated cornice, but a doorway molding supported by equally delicate fluted pilasters</i></p>

<p>5. PHYSICAL CONDITION OF STRUCTURE Endangered ? Interior <i>fair?</i> Exterior <i>Good</i></p>			
<p>6. LOCATION MAP (Plan Optional)</p>

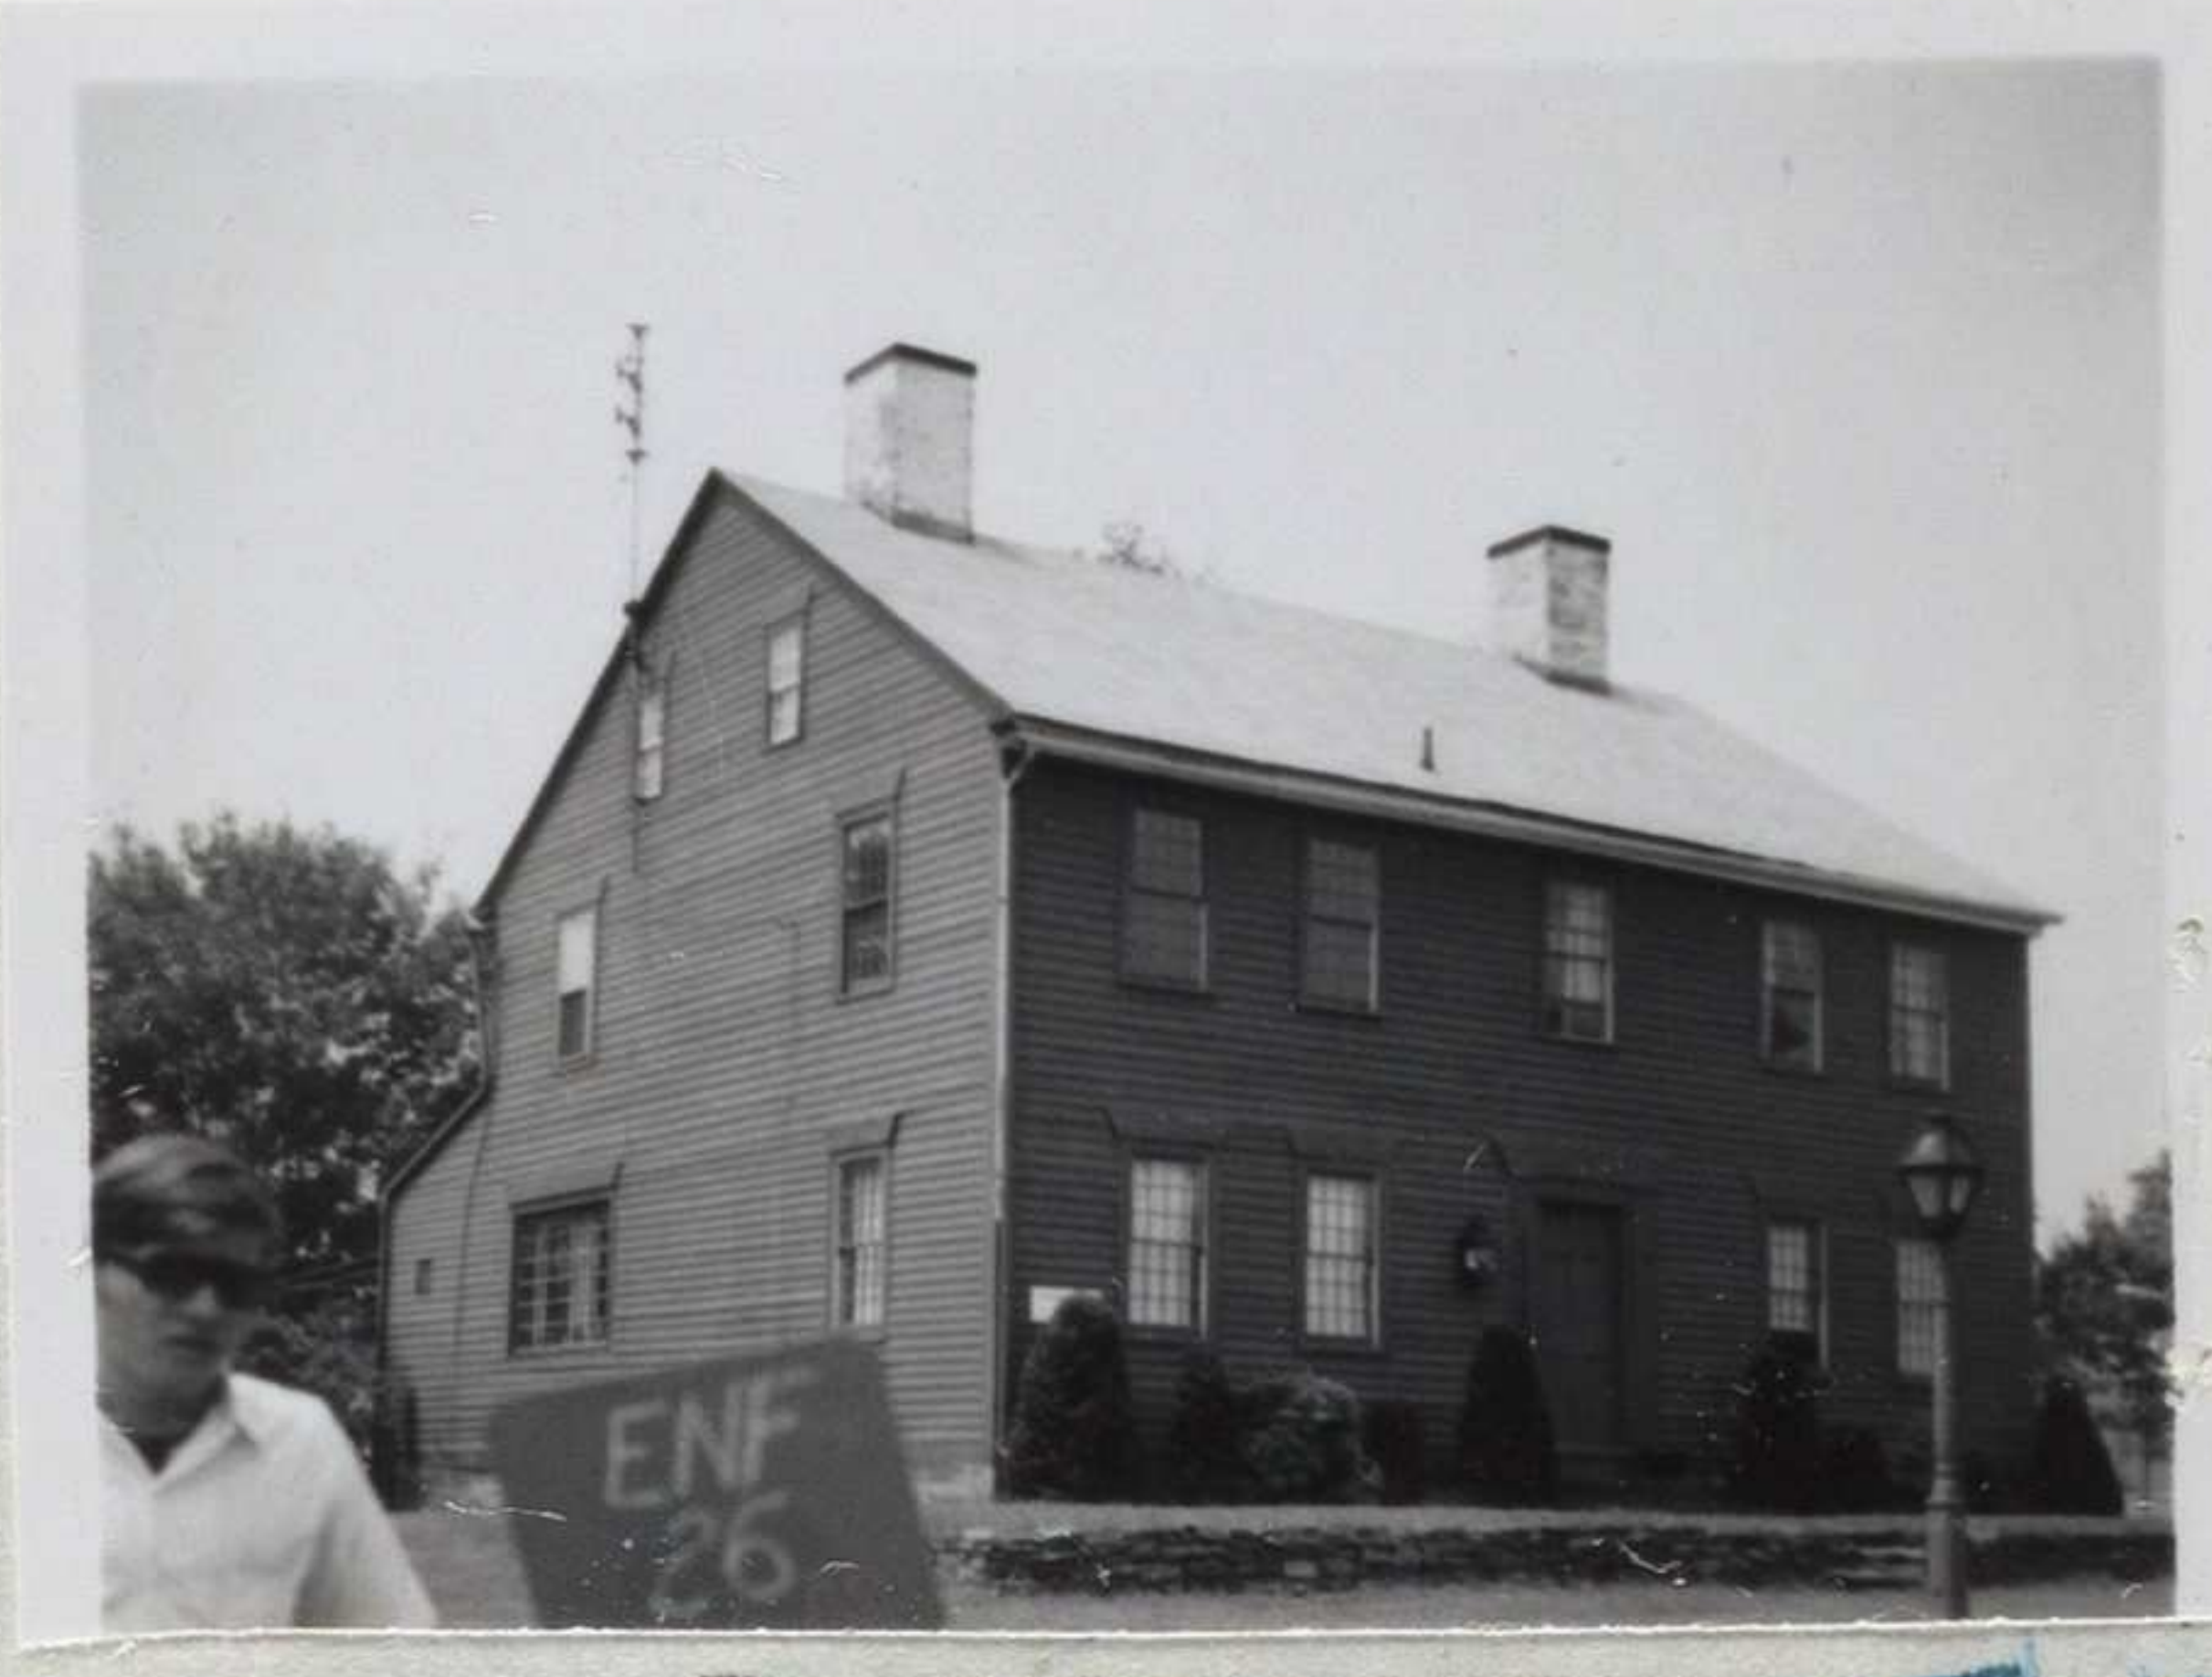
7. PHOTOGRAPH <i>Enf</i>

3. FOR LIBRARY OF CONGRESS USE	
4. NOTABLE FEATURES, HISTORICAL SIGNIFICANCE AND DESCRIPTION <div>OPEN TO PUBLIC <i>No.</i></div> <p><i>This house has recently been excellently restored. It is in the form of five bays. The door is single and simple. The 12/12 windows on the first two stories are capped with simple lintels.

of a single board. Like the clapboards these are deep red. The ²chimneys being at the sides leave space for two 6/6 windows of smaller dimensions, similarly capped on each pedimental face. The foundation is of brownstone, cut and scored.</i></p>

5. PHYSICAL CONDITION OF STRUCTURE Endangered ? Interior <i>good</i> Exterior <i>good</i>	
6. LOCATION MAP (Plan Optional)

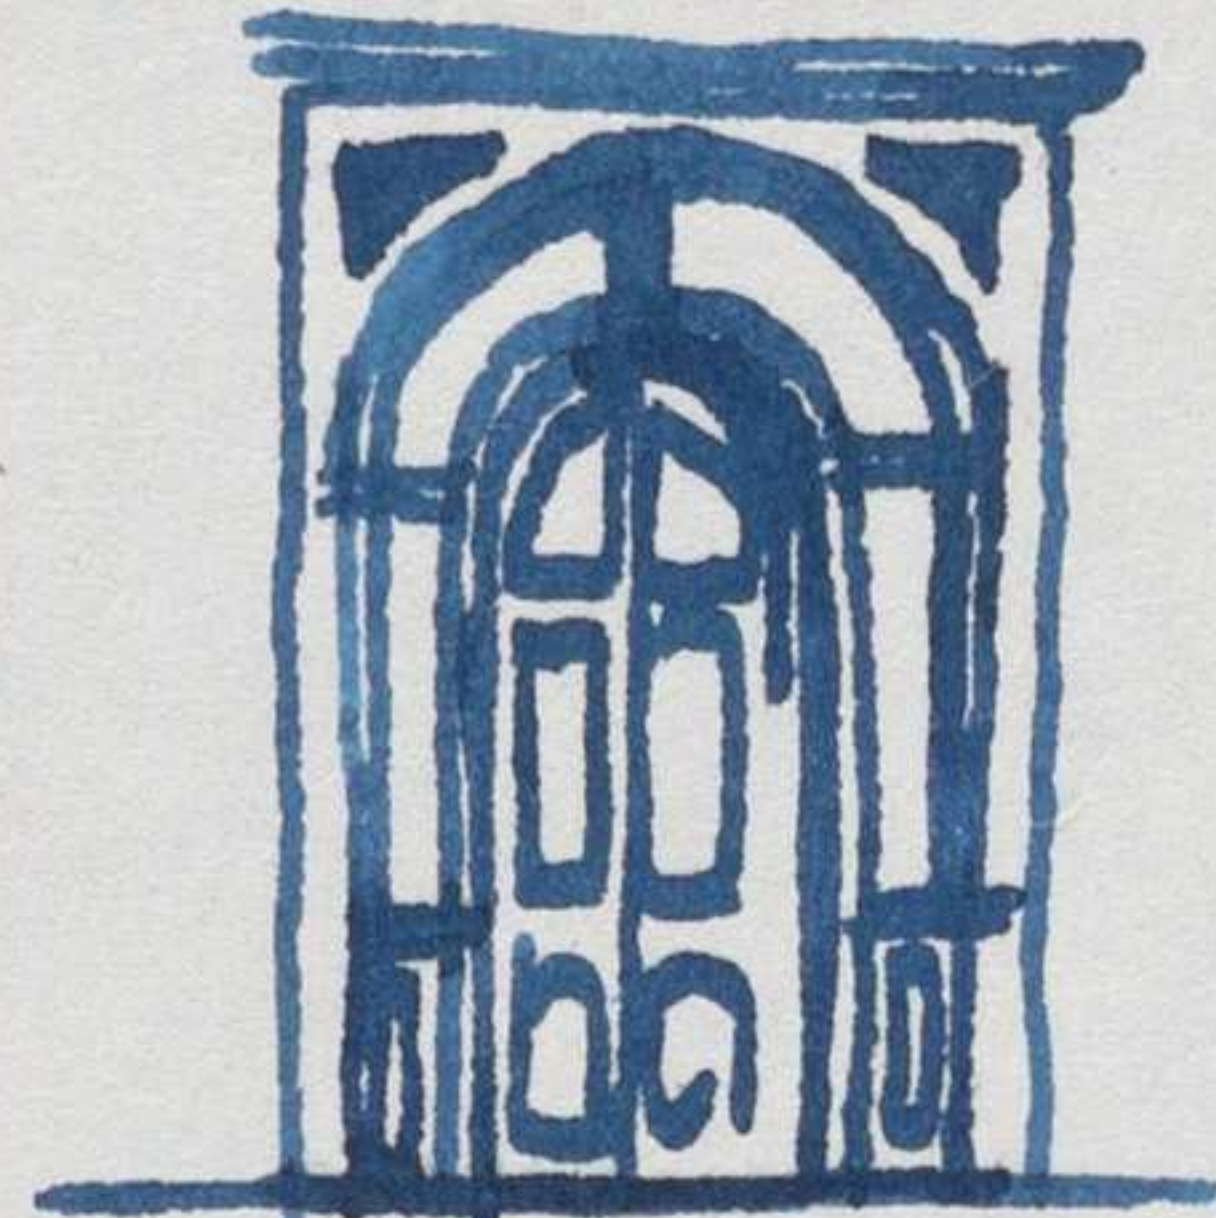
This Italian Villa Style house is made of two main stories with half windows for each of the three bays in the entablatures punctuated by pairs of elaborate consoles. The four-square shallow pitched roof is topped by a cupula with three round headed windows on each face. The left hand doorway has a rounded door with glass surrounding. A decorated porch accents the facade and side. To the right is three faced bay window.

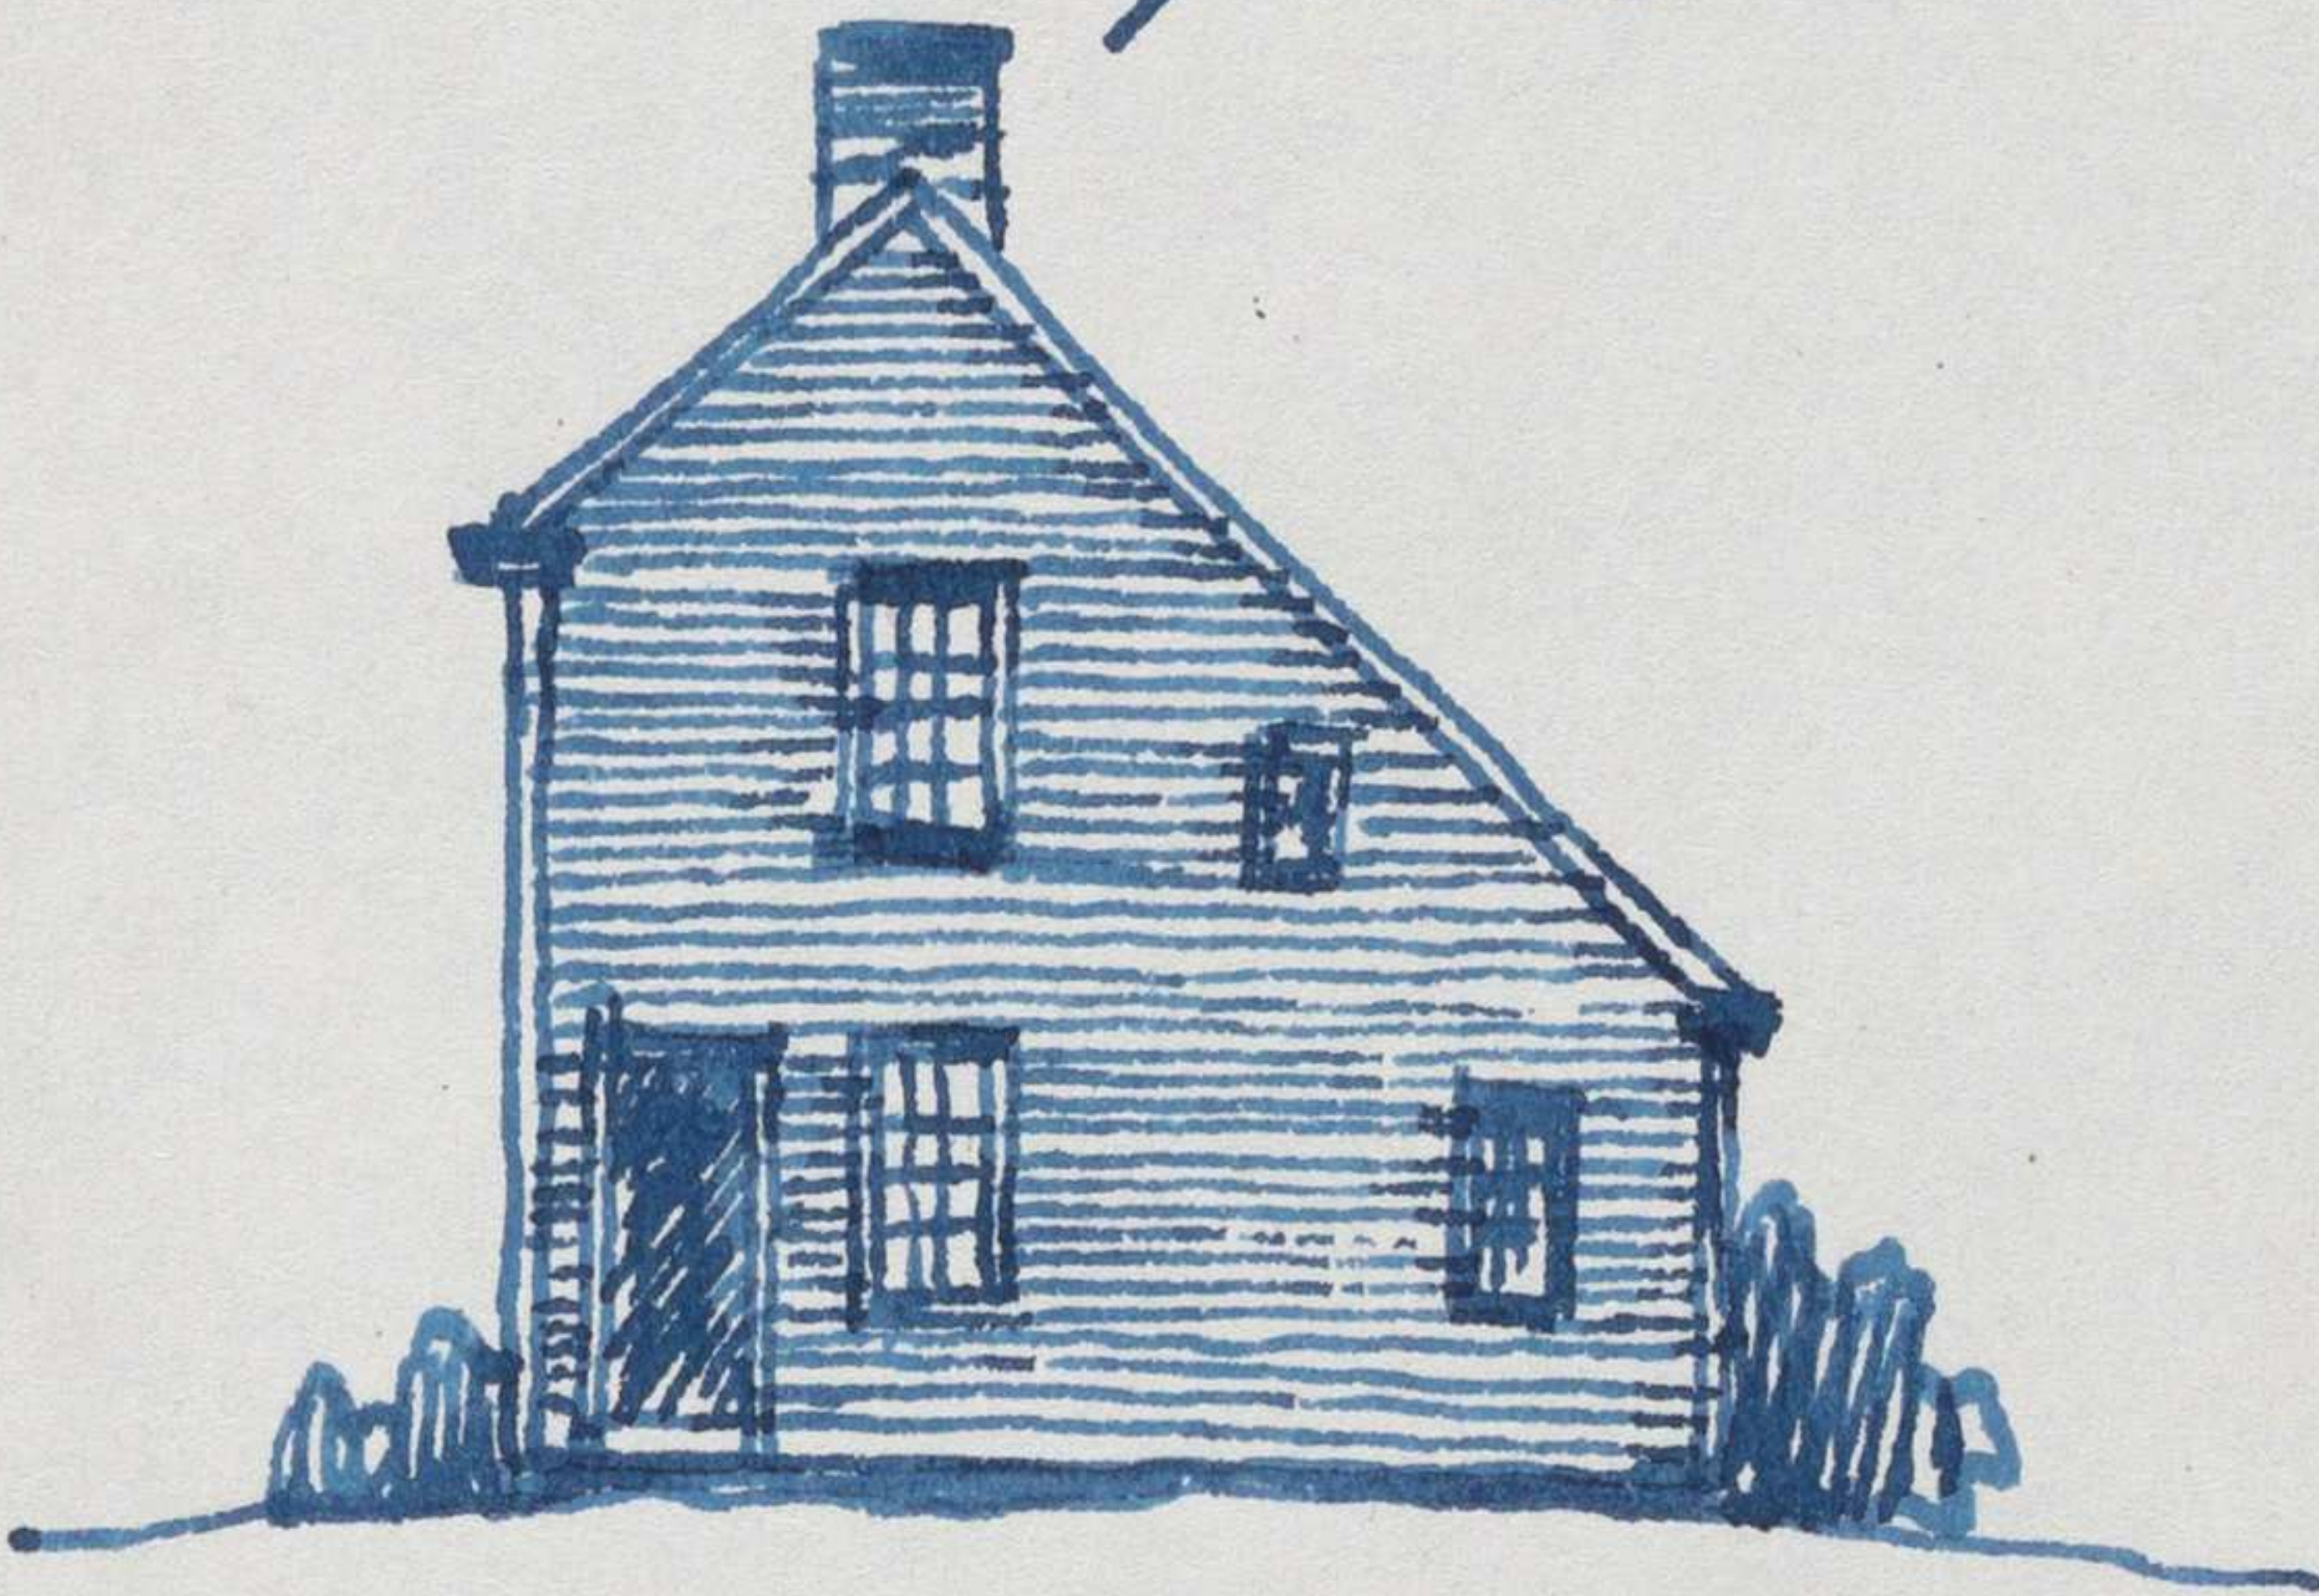
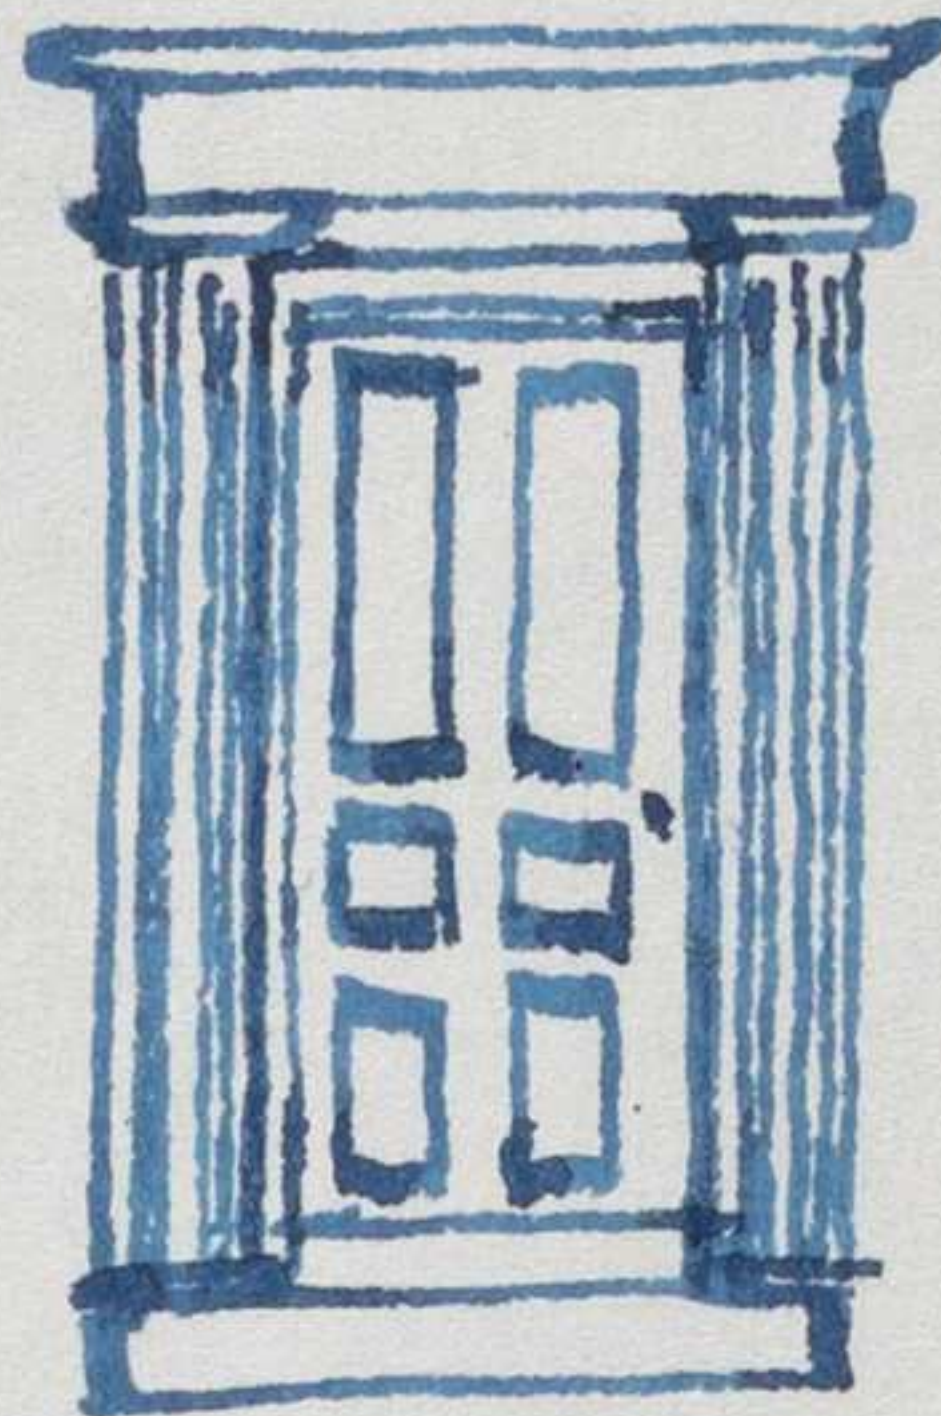
7. PHOTOGRAPH <i>Enf 35</i>	
8. PUBLISHED SOURCES (Author, Title, Pages) INTERVIEWS, RECORDS, PHOTOS, ETC.		9. NAME, ADDRESS AND TITLE OF RECORDER <i>Elric J. Endersby</i> <i>Elric J. Endersby</i>	
		DATE OF RECORD <i>7/11/67</i>

4. NOTABLE FEATURES, HISTORICAL SIGNIFICANCE AND DESCRIPTION		OPEN TO PUBLIC <i>No</i>	
<p><i>This is a very fine five bay, red clapboard saltbox house. It has its central chimney and simple forms for windows and the trim. The 6 panel door is framed with simple molded pilasters. The condition is quite fine</i></p> <div style="display: flex; justify-content: space-around; align-items: center;">

5. PHYSICAL CONDITION OF STRUCTURE		Endangered <i>No</i> Interior <i>good?</i> Exterior <i>good</i>	
6. LOCATION MAP (Plan Optional)		<div style="text-align: center;">

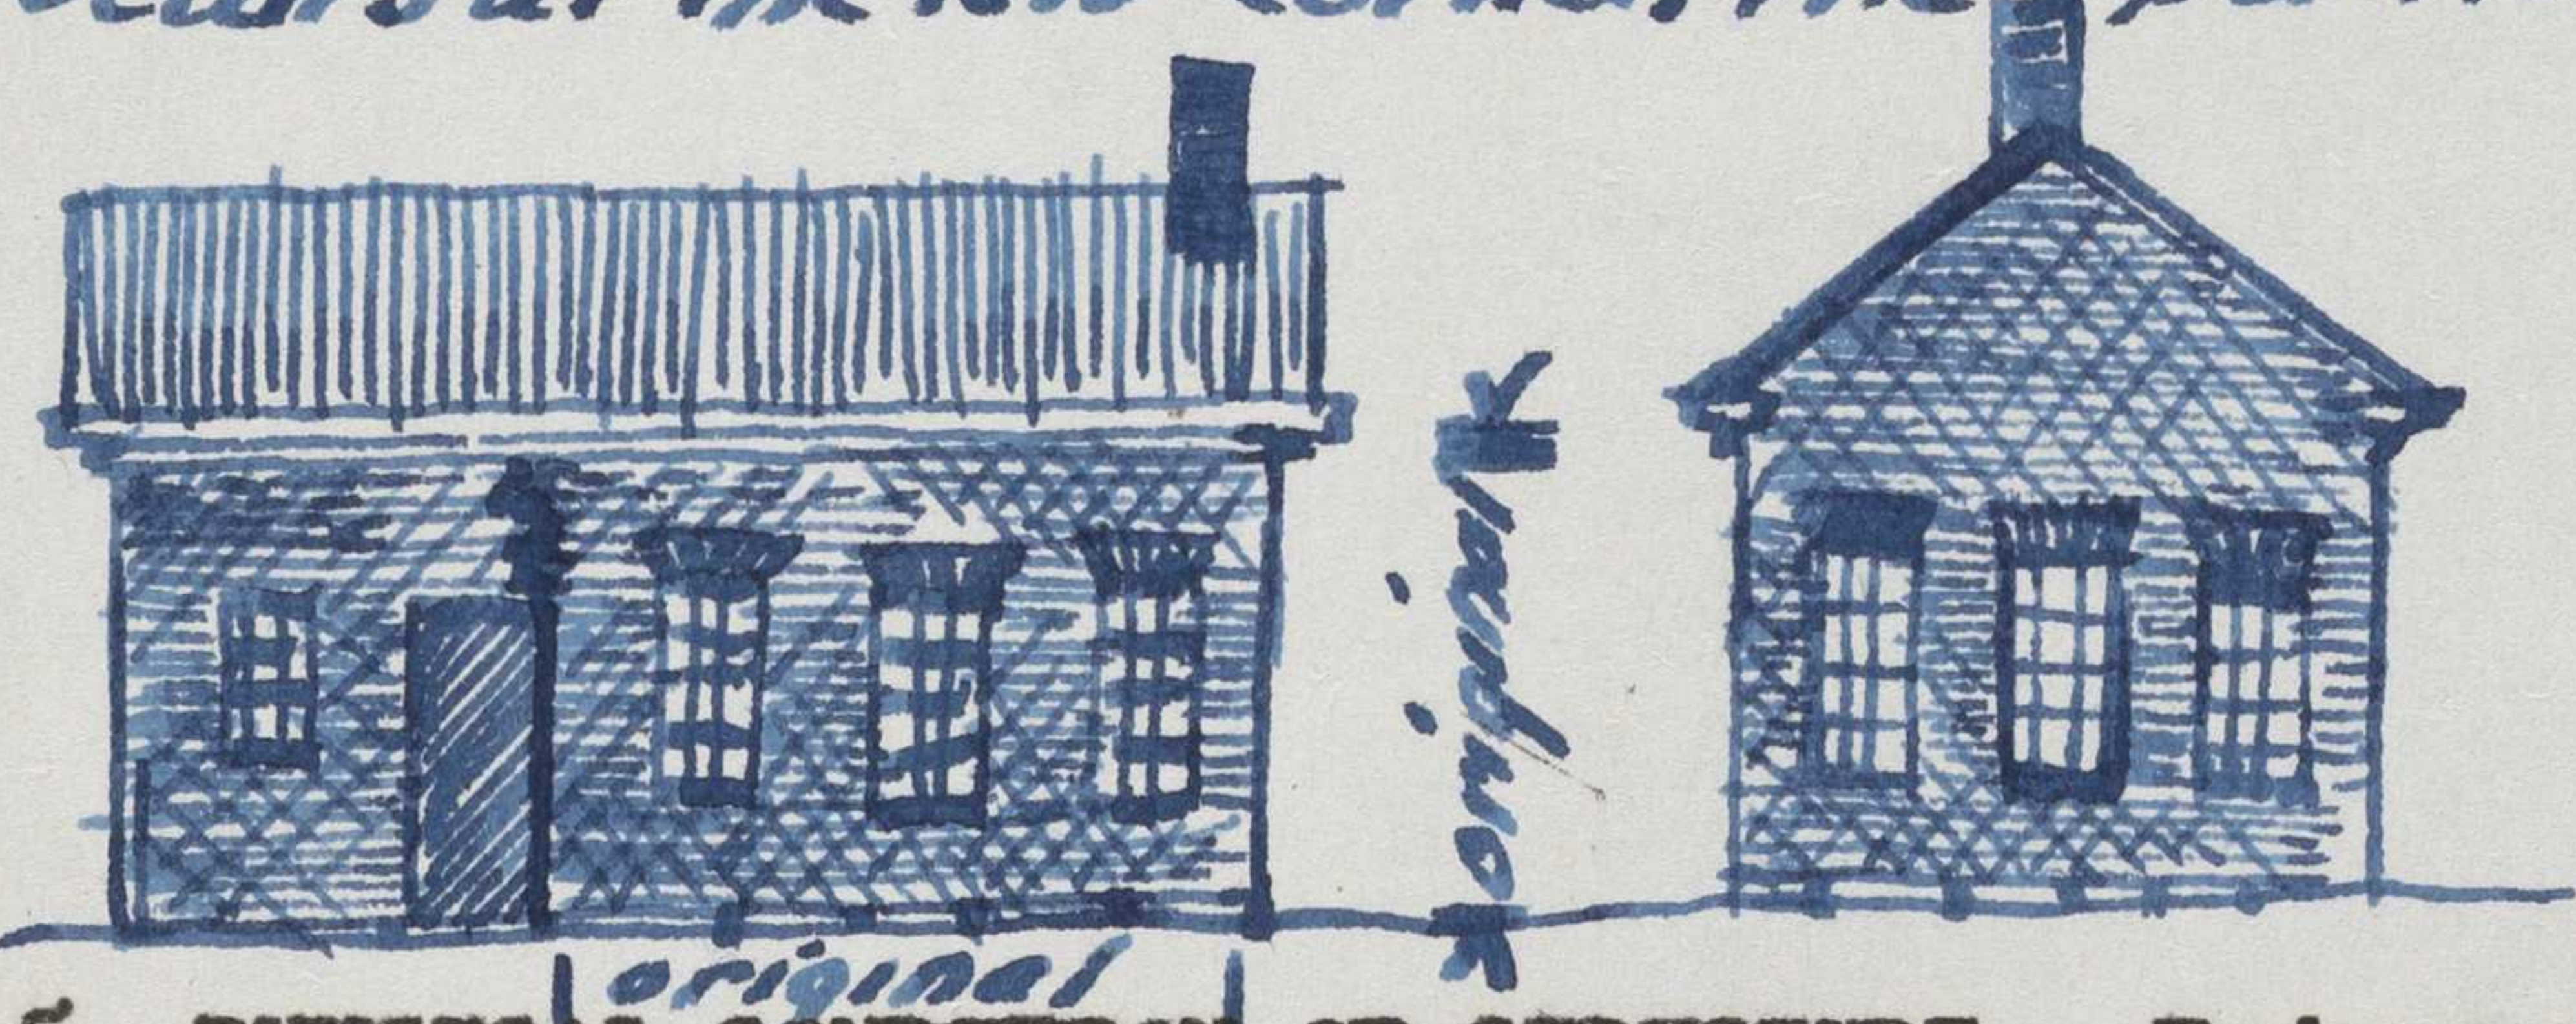
Flemish Bond *English Garden Wall*

This fine old school house was one of the as most interesting places we have visited. Used a single room school house until 1953, it was next the headquarters of the Civil Air Patrol. About ten years ago a fire did some damage but ~~now~~ the building is now in fine condition and will soon be in even better shape due to its acquisition by the Enfield Historical Society. The foundation is of cut brown-stone. The building must have been built by the community at large since the original portion is ~~but~~ layed with bricks of two distinct styles, Flemish Bond and English Garden wall. The change occurs at the NW corner. The portion added can be easily determined.

by the lack of style in the brick work. The break can be easily seen on the west wall by a distinct line. On the East face the break is the right frame of the door. The windows of the original portion are capped with flat arches of brick, the rest has no such
